Case Study

Application: Bucket Elevator

Location: Mineral Sands Plant, WA

Solution: Dodge ISN Bearings with Trident Seals

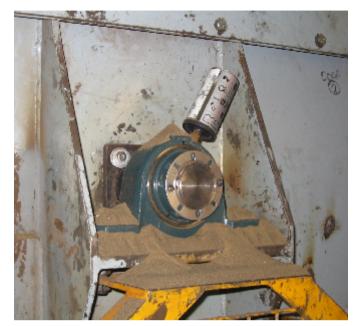
Design: The Dodge Trident seal has 3 high contact sealing lips running directly on the bearing inner ring, the 4th lip runs against the chip shield forming a grease dam.

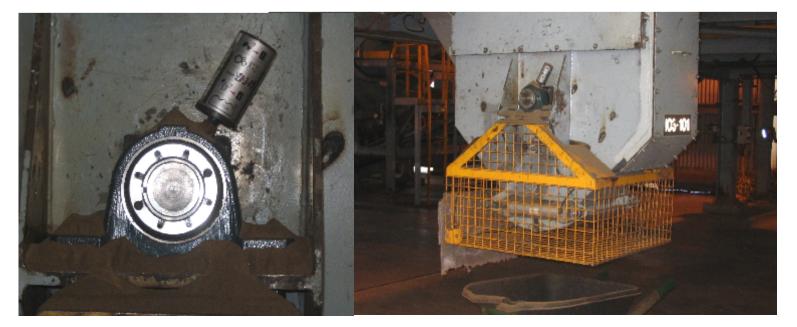
Problem: These photos were taken within hours of installation of the new DODGE ISN bearings. A constant build up of fine silica sand meant the old bearings were being changed out every 8-10 weeks. Even at installation it was impossible to keep this fine and very abrasive contaminant out, so even new bearings were contaminated before they even started turning.

Result: Bearings were quicker and easier to fit as the clearance is factory set. Also the dodge unit is supplied with the bearing and seal already fitted in the housing, so there is no opportunity for the bearing to become contaminated at set up. As a final touch Sima automatic lubricators were fitted giving an steady supply of Castrol APXT grease directly to the rolling elements, keeping the grease dam full and the contaminants out. The final result is an expected bearing life of 6 months plus. If they can make it this long the cost savings will run into thousands of dollars\$\$\$.
