# Leading Edge Repair and Protection for Wind Turbine Blades

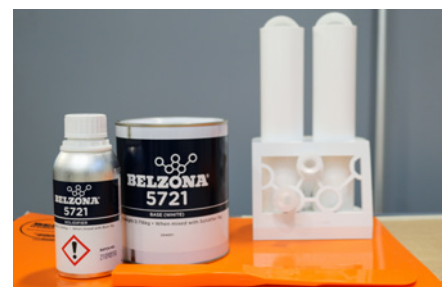
**Belzona 5711** can be used to rebuild pitted sections of the blade prior to application of Belzona 5721. Belzona 5711 is rapid curing and can be overcoated in 45 minutes, and is fully cured within 65 minutes at 20°C/68°F.
