CASE STUDY

Mining Conveyor Pulley – NSK Sealed Spherical Roller Bearings Solution

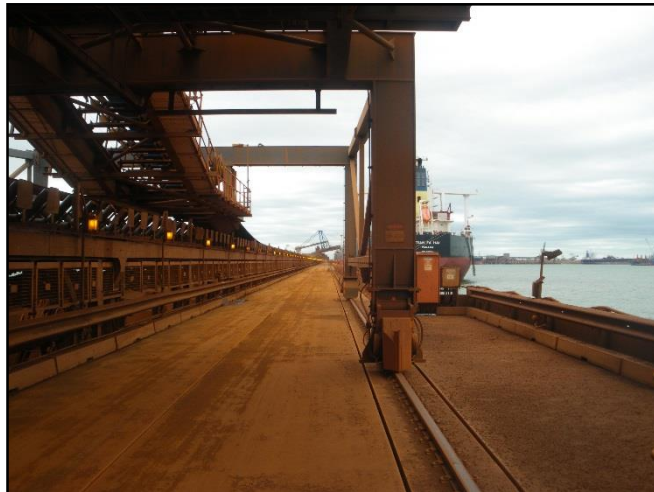
At a Pilbara Iron Ore Port Facility, a bend pulley on a ship loading conveyor was determined to have only 6 months operating life before change out was determined to be necessary, due to heavy Iron Ore particle ingress and water contamination in the lubricant leading to short operating life. This required regular and costly maintenance in both man hours and lost production.

NSK Engineering designed a Sealed Spherical Roller Bearing for the ship loading conveyor application that offered the Hi Tough™ material solution and removable nitrile (HNBR) garter sprung seals to extend the operating life. Tough Steel™ is an effective countermeasure to the wear commonly found on the outer ring raceway, where the fixed load zone material wears under fine particle ingress.

The NSK Sealed Spherical Roller bearings were installed and achieved an additional 12 months operational life.
